**Assessment of Drainage Conditions in the Vicinity of the 4th
Street Culvert on Eagle Valley Road in Yoncalla, OR.
8/1/2008**

**Continuation of previous report dated 8/1/2008
Current Condition: (9/30/08)**

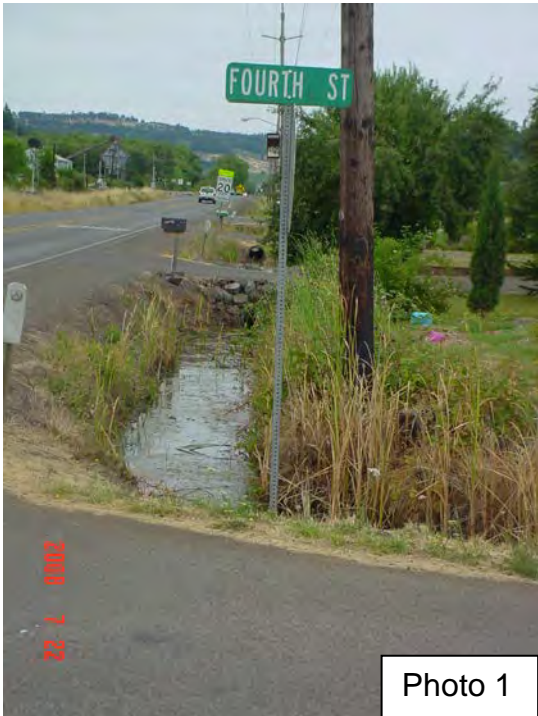
Photo 1 shows the ditches in question looking south from 4th Street toward 5th Street. Water depths of 20 inches were observed.

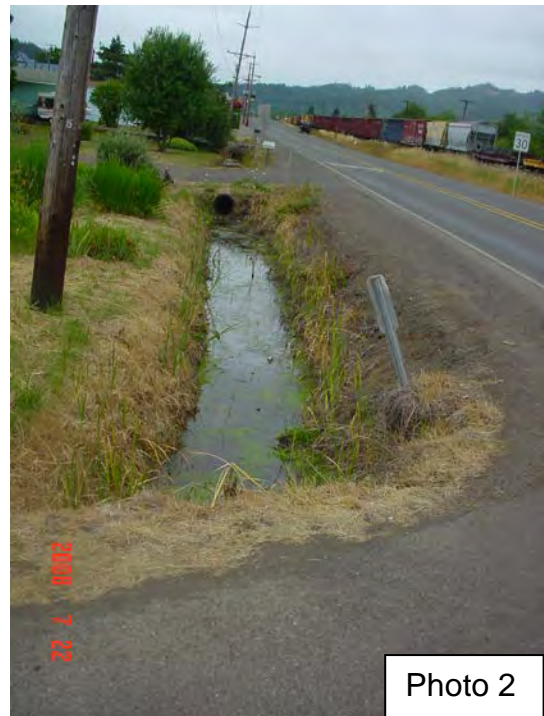
Photo 2 was taken from 5th Street looking north.

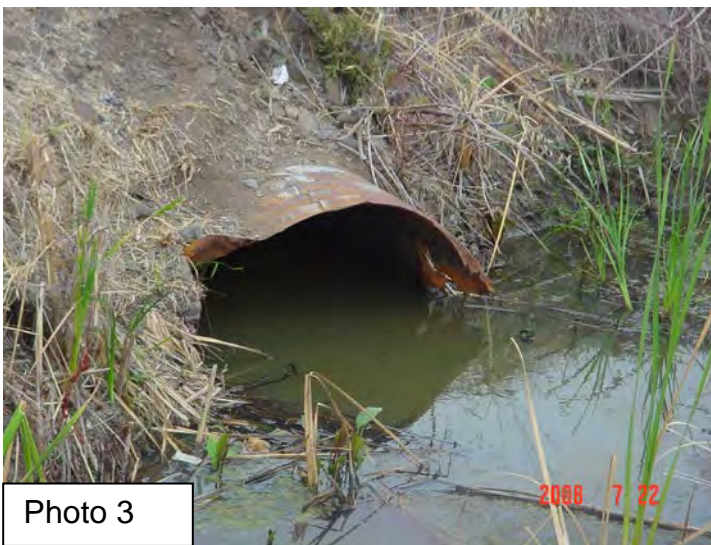
Photo 3 is a close up view of the 4th St. culvert which appears to be 36" dia. Note that there is no apparent flow and that the backwater is restricting the opening of the culvert to about 1/3 of its design capacity.

- 2. The increase in pond level does not cause any flooding directly but the increased backwater in the 4th Street culvert could seriously affect the performance of the culvert as it tries to drain the water from coming from the indicated drainage area (Photo 9).**

- 3. A possible solution to this situation is to adjust the outlet control of the pond so that the effective pond level is about 12 inches lower. This would vastly improve the drainage capacity of the 4th street culvert and should eliminate most of the backwater flooding.**

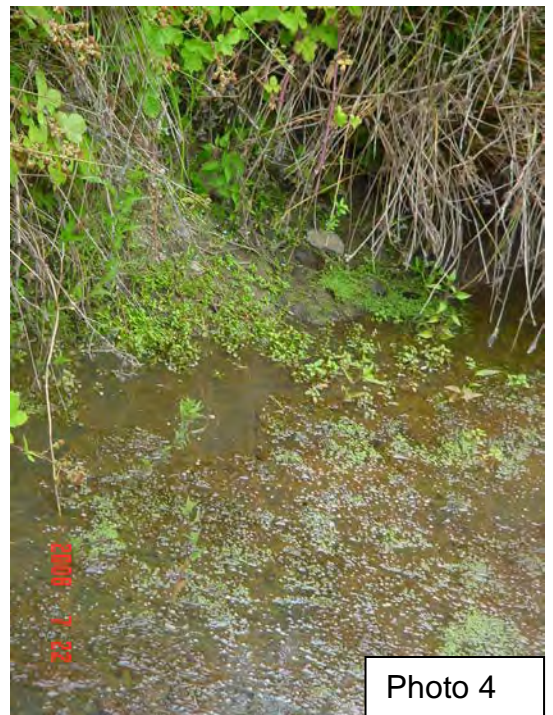
Photo 4 shows the corresponding backwater associated with the other end of the culvert on the east side of the railroad tracks. This water also appears to be stagnant and appears to be connected hydraulically with the mill pond.

- 1. It is possible that pond outfall control has become partially plugged, resulting in an increase in the surface elevation of the pond. The fluctuation of the water level during the drought period suggests that beaver or other animal activity may be involved.**

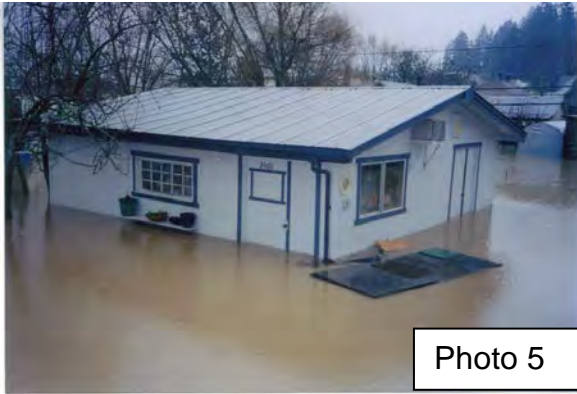
Photo 5

Photos 5-7 shows water levels that occurred in January 2005. Note that the water is flowing across Eagle valley Road into the east-side ditch. In Photo 8 Mr. Maccabee is showing the water level reached in November 1996.

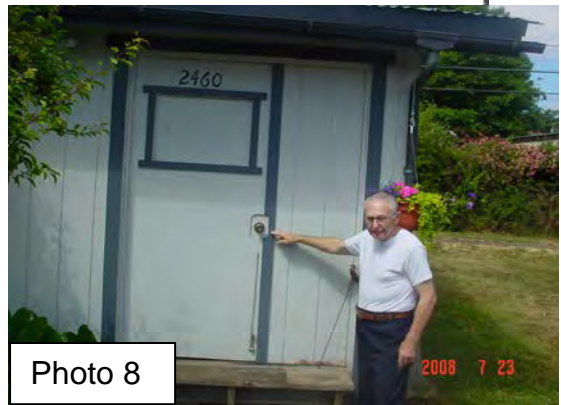
Photo 8

According to Mr. Maccabee, a local resident, during the flooding episodes the water starts to pond on the high school grounds and then moves north crossing 5th Street and continues to rise until it crosses Eagle Valley Road. He also stated that he has seen the water level fluctuate as much as 10 inches during the past month (no precipitation).

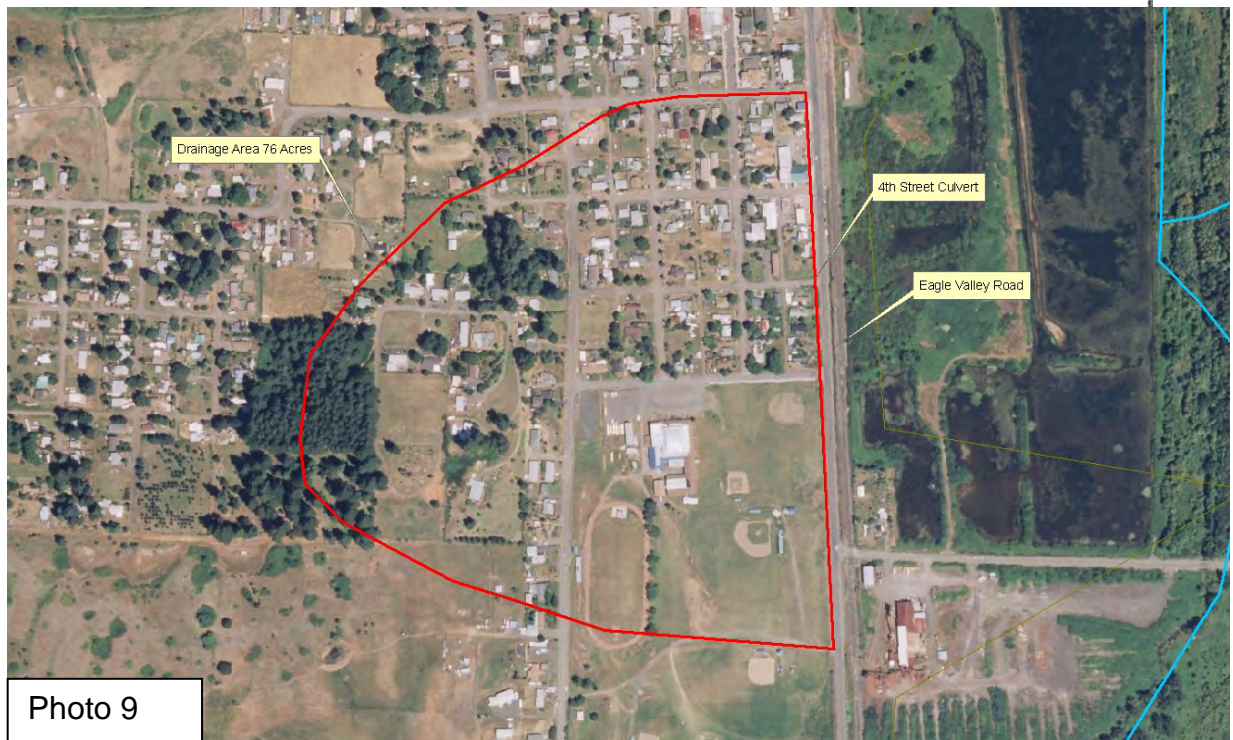
Photo 9 shows the estimated drainage area (76 acres) based on contours from a 10m DEM.

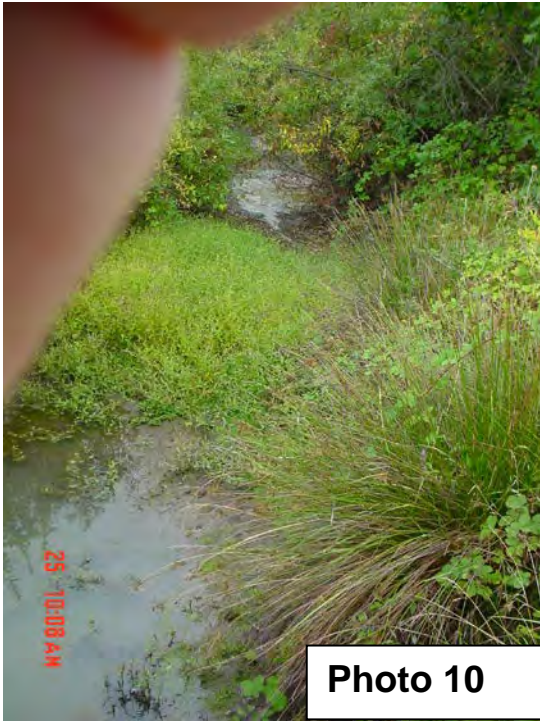
By September 30 the mill pond level had receded and, as shown in Photo 10, the culvert is not, at this time, being affected by backwater from the pond. However, Photo 11 shows that the west inlet end is significantly below the drainage grade. In this photo, only 22 inches of the 34 inch vertical opening is not submerged. It appears that the culvert inlet is more than 12 inches below the effective drainage grade. As a result, during full flow conditions the culvert will function in a reduced capacity.

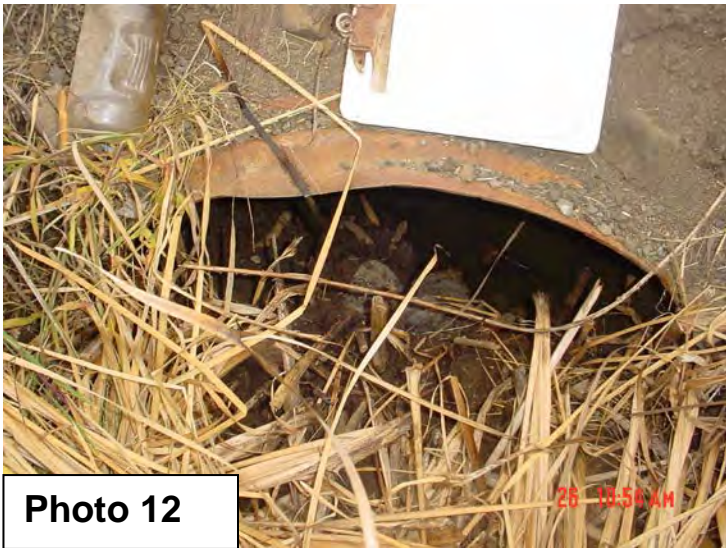
The lower pond level also provided an opportunity to easily inspect the outlet end of the culvert on the east side of Eagle Valley Road as well as the inlet side of the railroad box culvert. Photo 12 shows the outlet side of the culvert that is approximately 90% plugged with sediment and debris. Photo 13 shows the cleared condition of the railroad culvert that measures approximately 40 by 50 inches.

- 1. If possible, attempt to keep the mill pond level below the critical level that backfills into the culvert. This action would be particularly useful during winter rain season.**
- 2. Assure that the pipe culvert outlet and connecting ditch to the railroad culvert is clear of all obstructions to assure maximum flow for the existing configuration.**
- 3. Check the culvert size requirements for this drainage and, if it is larger than the current effective capacity (with 12 inches below grade) then consider options to increase the effective rate of drainage for this area.**
- 4. The ditches in the vicinity of the inlet appear to be below grade and, as a result, retain perennial standing water. This condition is a hazard from both a health and safety standpoint. Filling these ditches to grade level might alleviate this condition.**
