Case Study: Nutria Management at the Yoncalla Log Pond

Prepared by: North Douglas Betterment

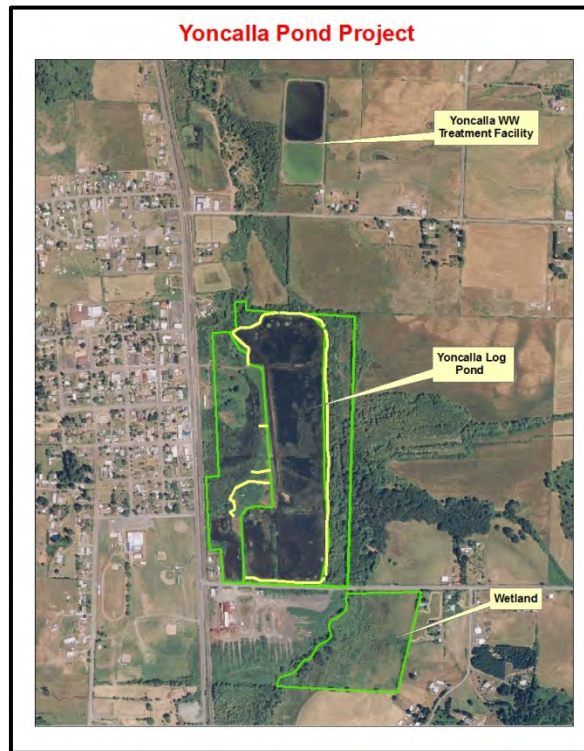
One of the first tasks was to clear the brush on surface of the pond dike (yellow line on map) to provide access to the property and to assess the condition of the dike. Exposure revealed that there were about thirty areas along the north and east side of the pond that had significant nutria damage (See photos page 2).

Dike Management: Brush clearing and nutria damage repair.

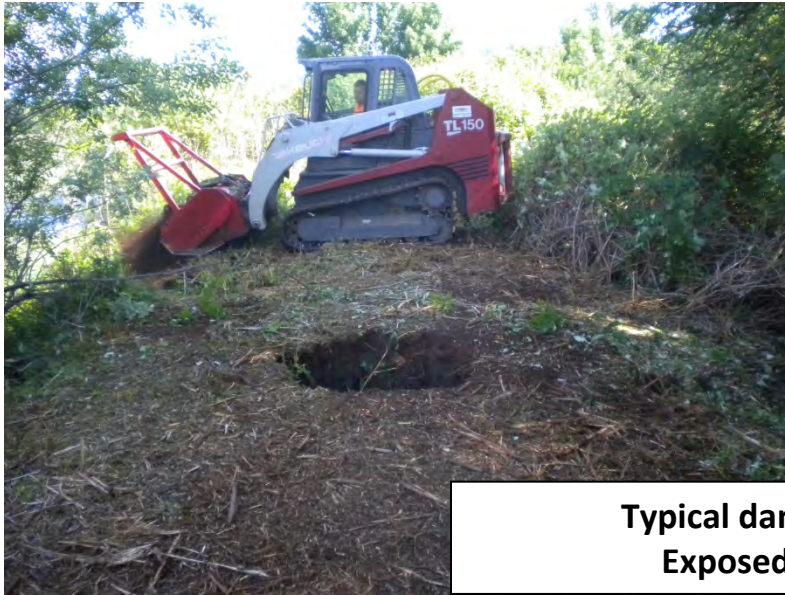
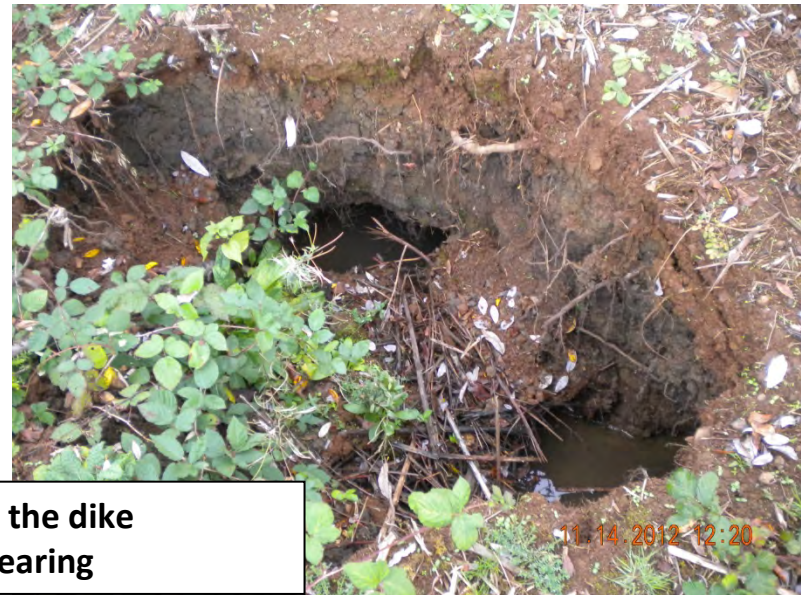
**Typical damage on the dike
Exposed after clearing**

In November, 2012 an effort was made to repair some of the damage by using a backhoe to dig out and refill the burrows. Over 200 yards of fill material was brought in and compacted into the dike.

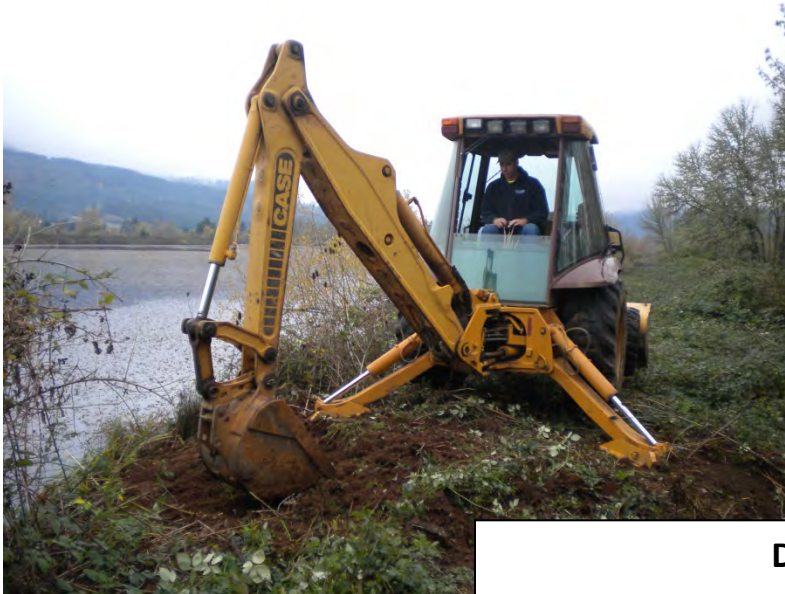
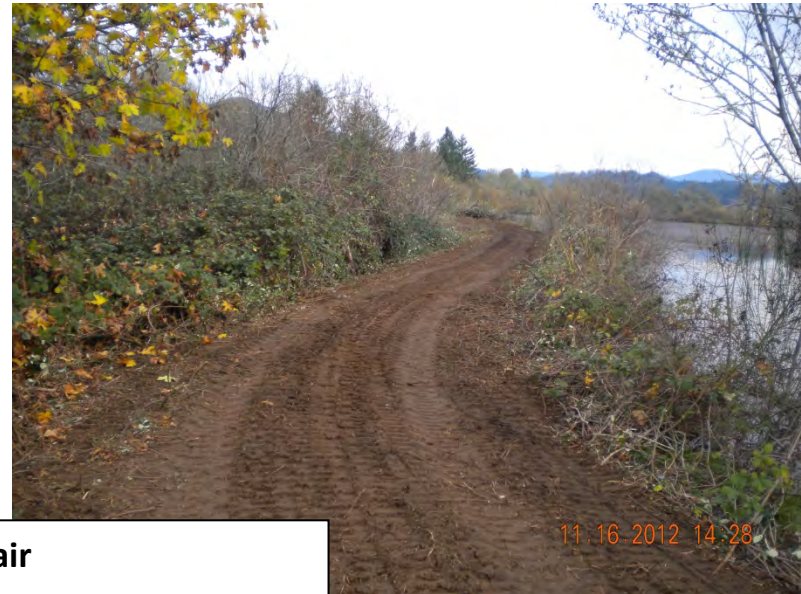
Dike repair

2. Repairing the holes in the dike in November may have produced significant mortality on the nutria population. The backhoe operator reporting seeing nutria exiting the burrows as he worked on them and it is possible that some of them did not escape. Also, nutria that had lost the sanctuary of their burrows may have died due to exposure.

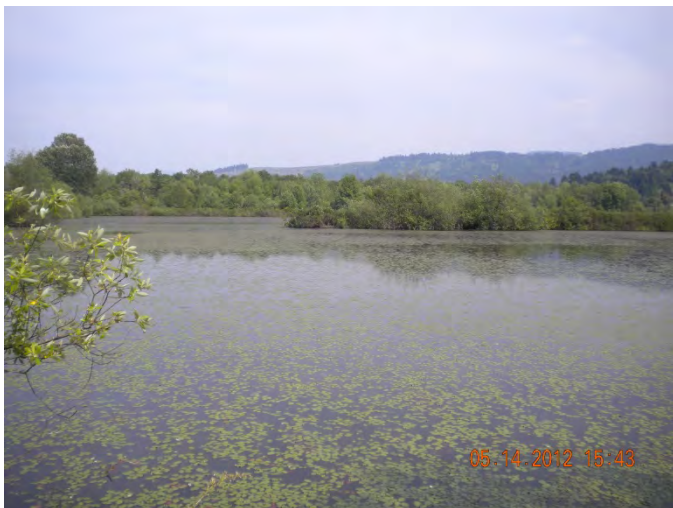
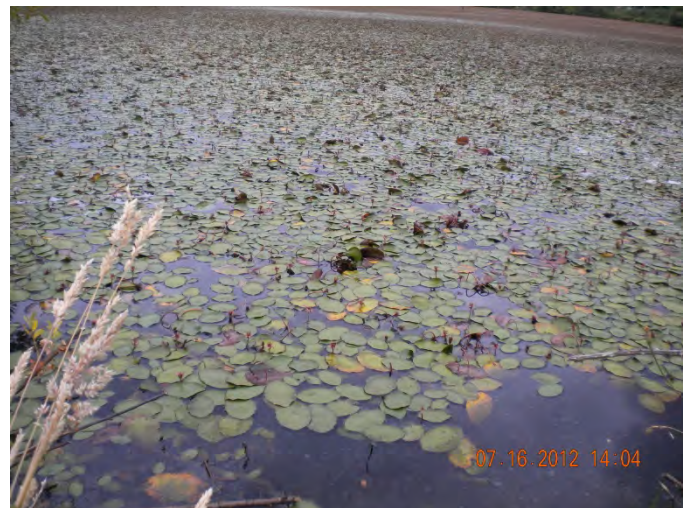
During 2012 the Pond had extensive water-shield growth

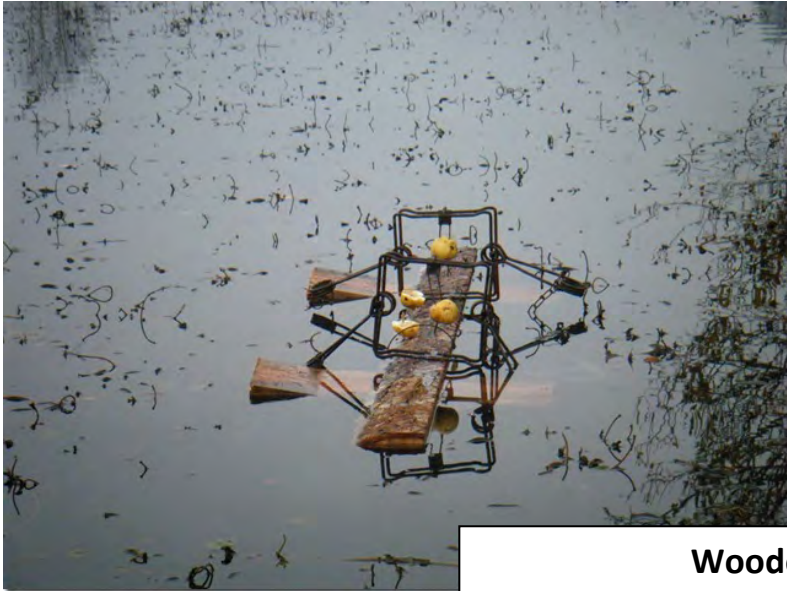
I chose to build floats and set the traps on the floats. I set them next to large willows along the bank in the nutria travel ways. Any nutria swimming along the banks would see and smell the bait and lure and then climb on the floats and get trapped. The traps would dispatch the nutria and sink into the water with the dead nutria.

Wooden float traps

The Styrofoam float worked better and was smaller than the larger wood slat floats so I would invest in some Styrofoam for next year to build the floats. The wood slat floats became water logged and eventually sat much lower in the water. They were also large and cumbersome in and out of the boat. The drift boat worked great and offered greater stability and I could launch it anywhere along the dike. It glided over the water vegetation effortlessly compared to a flat bottom or "V" hulled boat. No motor was needed.

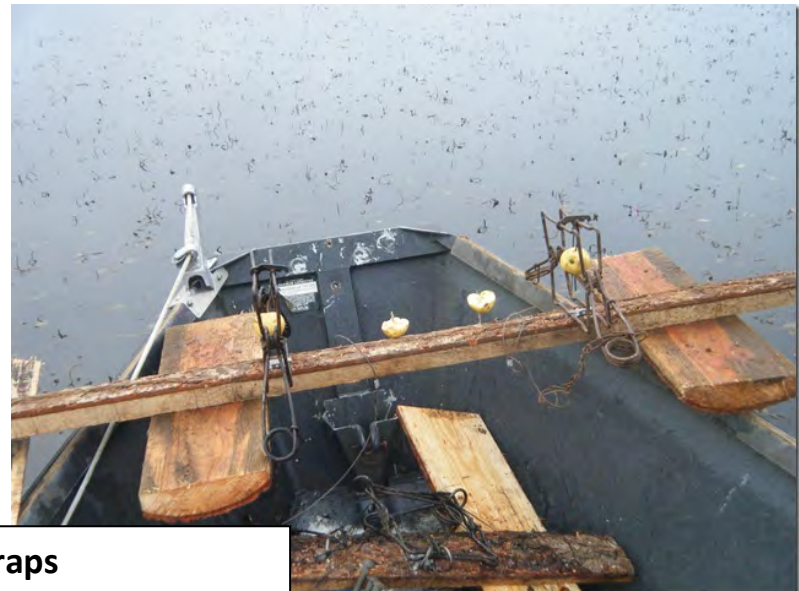
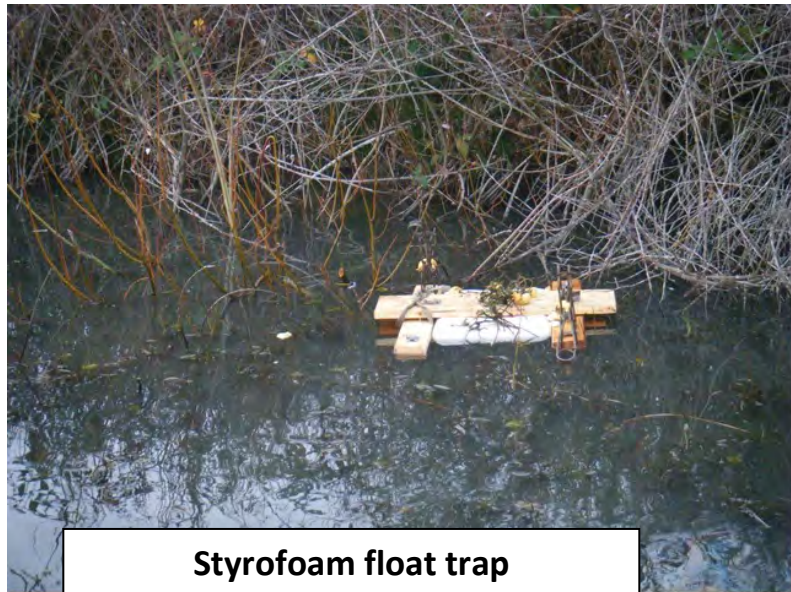
Styrofoam float trap
